St. Stephen's P. E. Church
East New Market
public worship

Maryland Historical Trust State Historic Sites Inventory Form

Survey No. D-173

historic ST. STEPHENS EPISCOPAL CHURCH

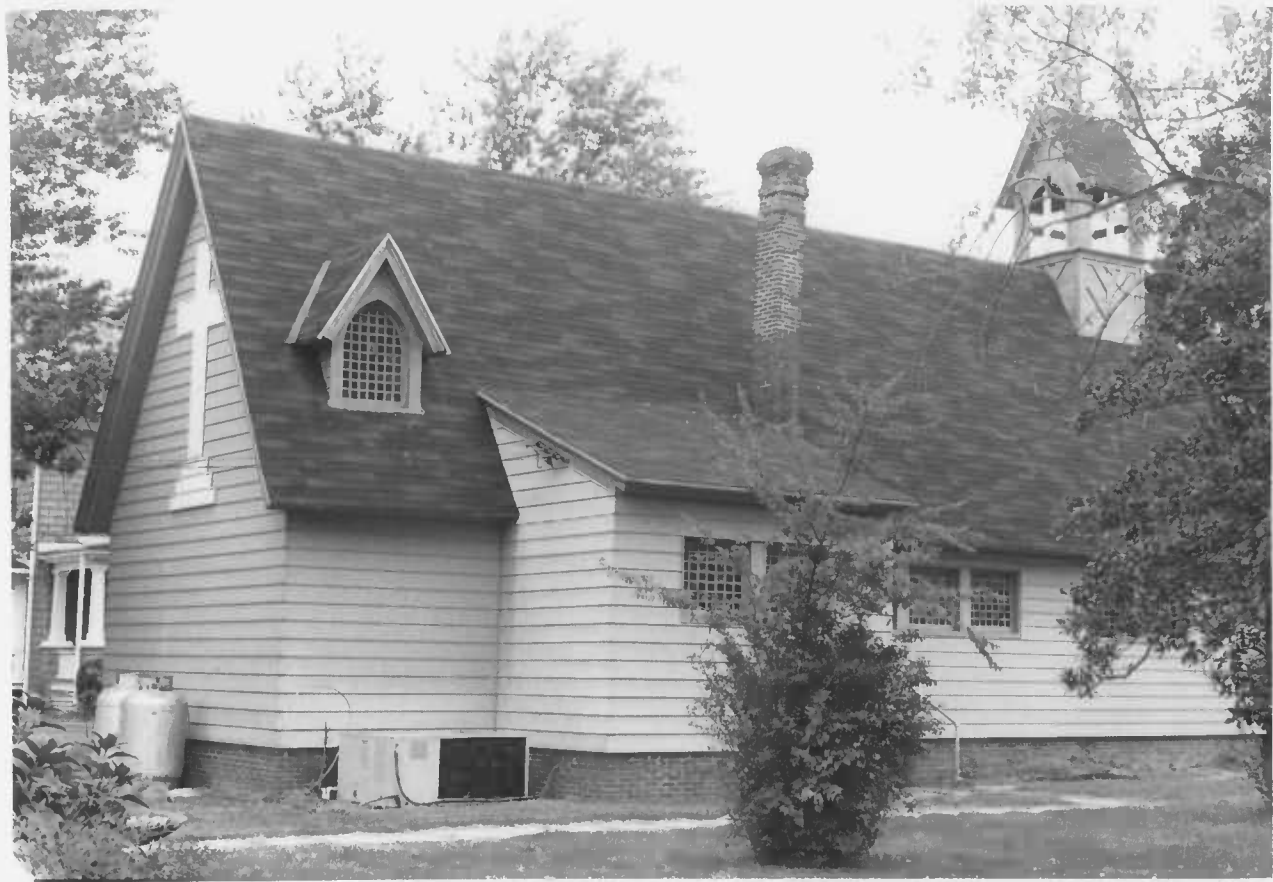
ST. STEPHENS P. E. CHURCH D-173
East New Market, Dorchester Co., MD
South elevation
10/87 Paul Touart photographer
Negative/MD Historical Trust

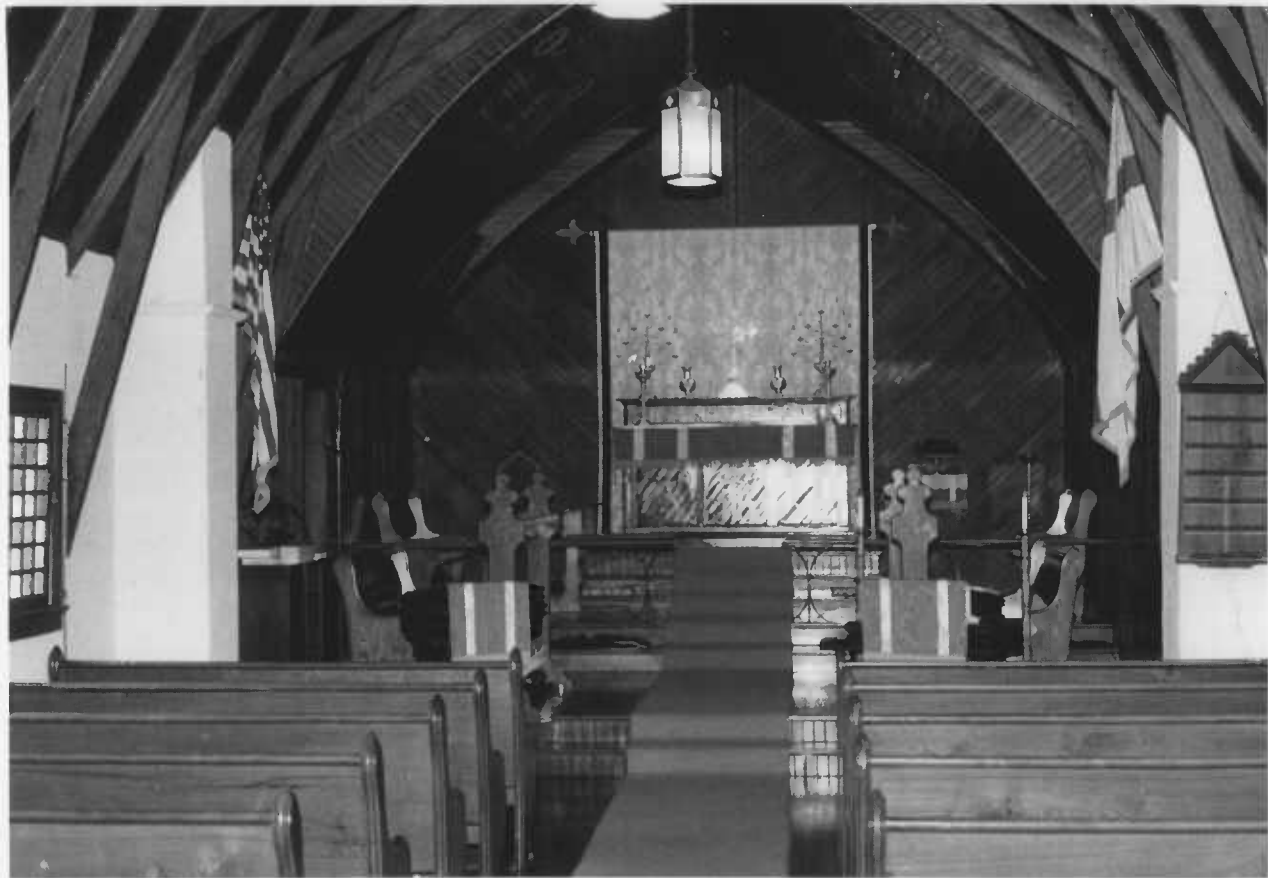
ST. STEPHENS P. E. CHURCH D-173
East New Market, Dorchester Co., MD
Interior
10/87 Paul Touart photographer
Negative/MD Historical Trust

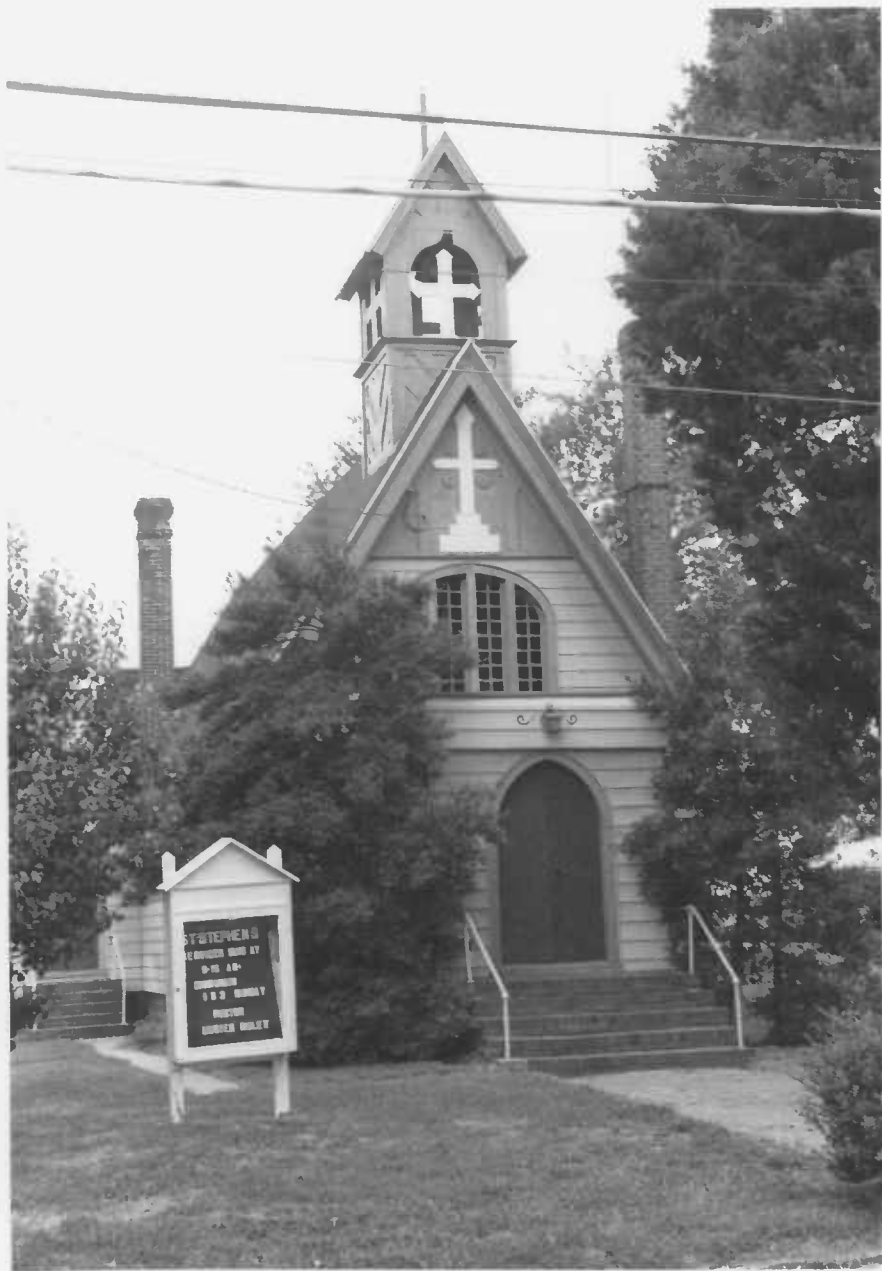
East elevation

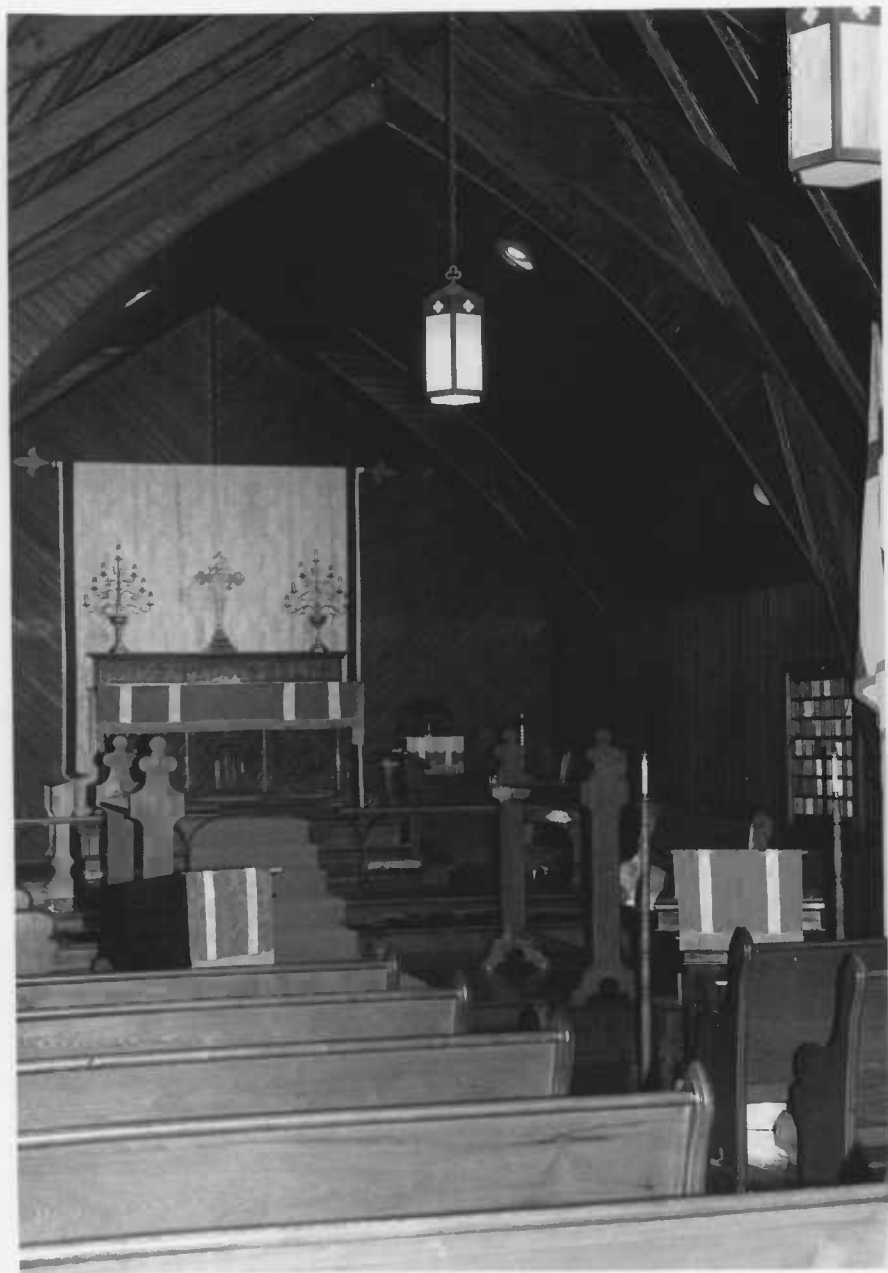
ST. STEPHENS P. E. CHURCH D-173
East New Market, Dorchester Co., Md
Interior
10/87 Paul Touart photographer
Negative/MD Historical Trust

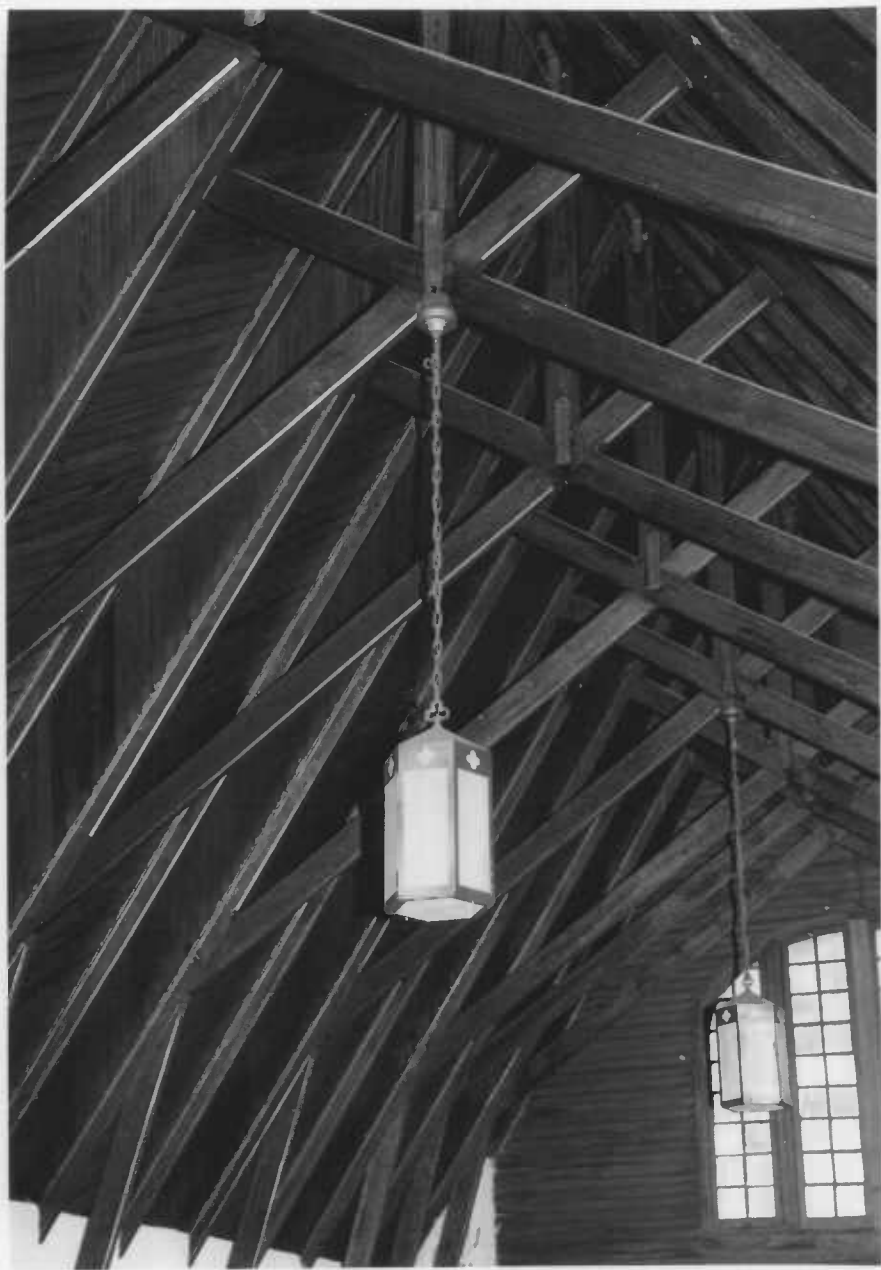
ST. STEPHENS P. E. CHURCH D-/73
East New Market, Dorchester Co., MD
Scissors truss roof system
10/87 Paul Touart photographer
Negative/MD Historical Trust
